NRL Report 5680

SURFACE CHEMICAL METHODS OF DISPLACING WATER AND/OR OILS AND SALVAGING FLOODED EQUIPMENT

PART 2 - FIELD EXPERIENCE IN RECOVERING EQUIPMENT DAMAGED BY FIRE ABOARD USS CONSTELLATION AND EQUIPMENT SUBJECTED TO SALT-SPRAY ACCEPTANCE TEST

U. S. NAVAL RESEARCH LABORATORY
Washington, D.C.

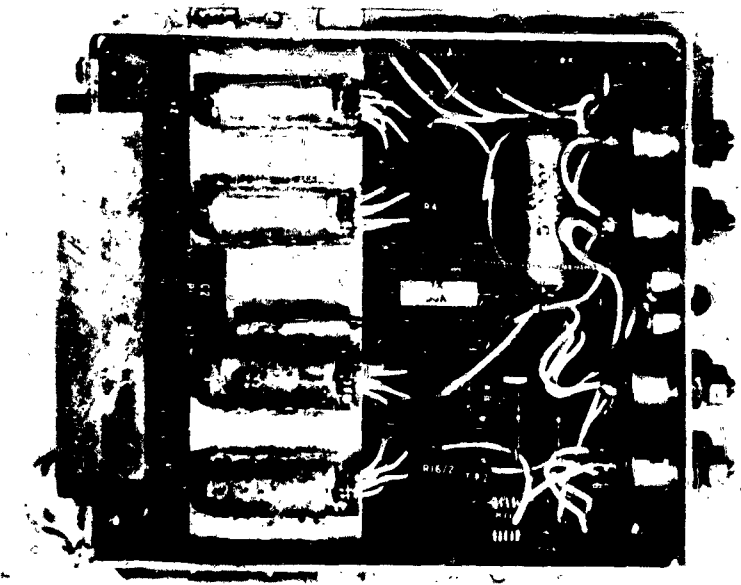
(a) - Appearance before cleaning

(b) - Appearance after cleaning

Fig. 4 - AMCS (Aero 1A Radar) electronic module
damaged by salt spray

Personnel assisting in the reconditioning work noted that the ultrasonic exposure was remarkably effective in removing salt corrosion products from aluminum and brass surfaces. Although no oily contamination was present the emulsion cleaner was still essential because of its ability to loosen and suspend such corrosion products. However, a much lower proportion (10 percent) of the concentrate in water was sufficient in the absence of oil and grease. The results of the recovery procedure are illustrated in Figs. 4 and 5.

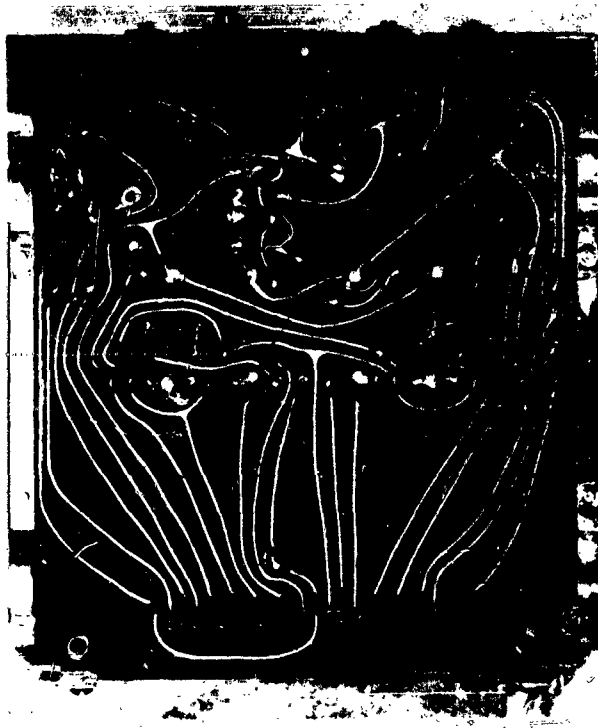
(a) - Appearance before cleaning

(b) - Appearance after cleaning

Fig. 5 - AMCS (Aero 1A Radar) printed circuit damaged by salt spray
